MECHANICAL SEALS FOR HIGH-SPEED BOILER FEED PUMPS IN ULTRA-PURE WATER

Eric Vanhie
Technical Specialist
EagleBurgmann
Houston, Texas, United States

Benjamin Weiss
Technical Specialist
EagleBurgmann
Wolfratshausen, Germany

ABSTRACT

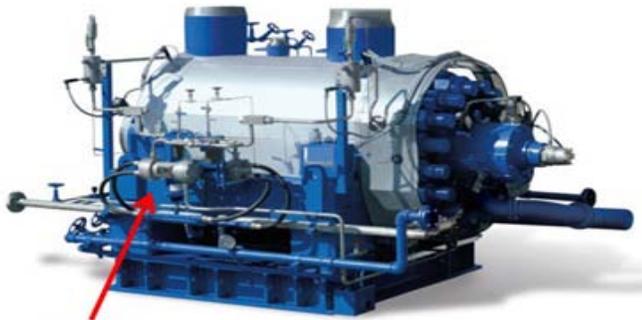
Typically, these seals operate with a cooling system (API Plan 23) to reduce the water temperature to approximately 120 -140°F (50 - 60°C) in the area of the seal (Figure 2). It was not until the introduction of neutral feed water conditioning in nuclear boiling water reactor systems (1980s), and more recently, the Combined Oxygen Treatment (COT) in new fossil-fueled stations (1990s), that corrosion problems in mechanical seals started to occur.

API plan 23 heat exchangers and magnetic filters

Figure 2: Barrel type boiler feed pump

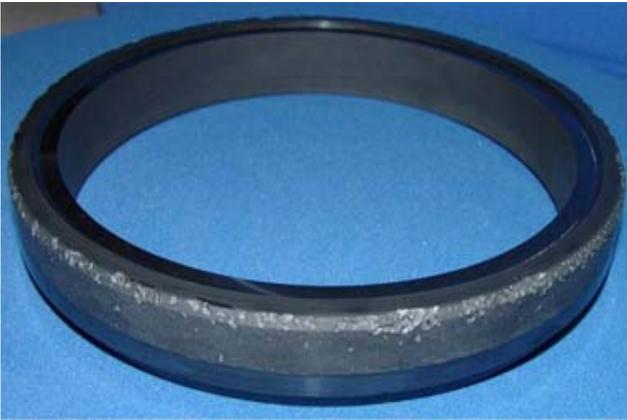
The first test was successful with uncoated rings in that it was possible to duplicate the damage as seen in the field (Figure 10). The following operating conditions were applied: pressure of 580 psi (40 bar) and a sliding velocity at the seal-face mean diameter of 196.8 ft/s (60 m/s). The second test with coated seal faces was successful since no damage was detectable under identical conditions and run-time. These promising results instigated long-term testing with periodic inspections of the seal faces. As this was a new seal face technology for this kind of demanding applications, the first tests included a series of transient conditions, including slow-roll and start-stop operation to verify and validate the tribological behavior of the seal faces.

Figure 10: Uncoated, conventional seal face after 600-hours on the test rig.

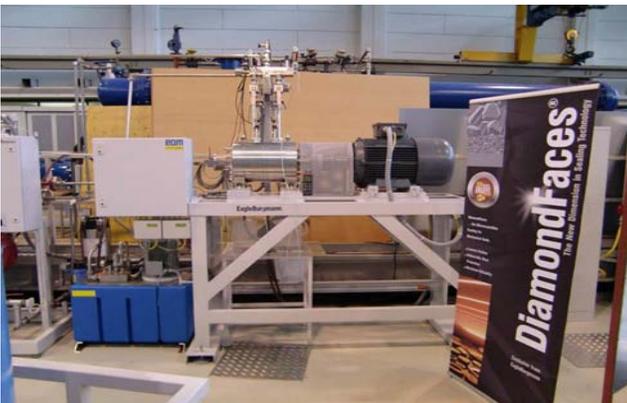
In order to build confidence for the proposed solution, it was imperative to verify the performance of the seal faces for at least 16,000 operating hours. This project is being handled in collaboration with the University of Graz (Figure 11). Actually, the running time is approximately 20,000 hours (dated 02/01/2012) and the seals show no attack of any kind. All relevant monitored performance indicators such as leakage rate, face temperature and water electrical conductivity at the seal faces are constant and consistent.

Figure 11: Long term test set-up at the University of Graz

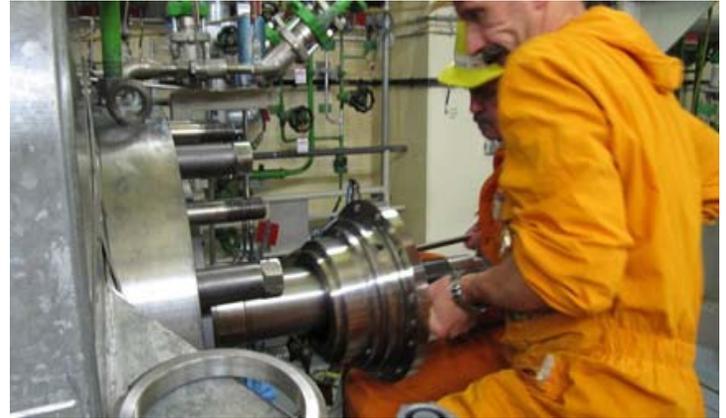
In October 2010, the first field installation took place at the nuclear power station Isar I in Germany and startup was on October 17 (Figure 12). The seals performed well without any signs of degradation, but unfortunately the plant was shut down shortly after the tsunami accident in Japan.

Figure 12: Installation of the first seal with Diamond Face® technology in a reactor feed pump at the Nuclear Power Station Isar I
